Church of St Mary, Breamore, Hampshire.

Breamore, Hampshire

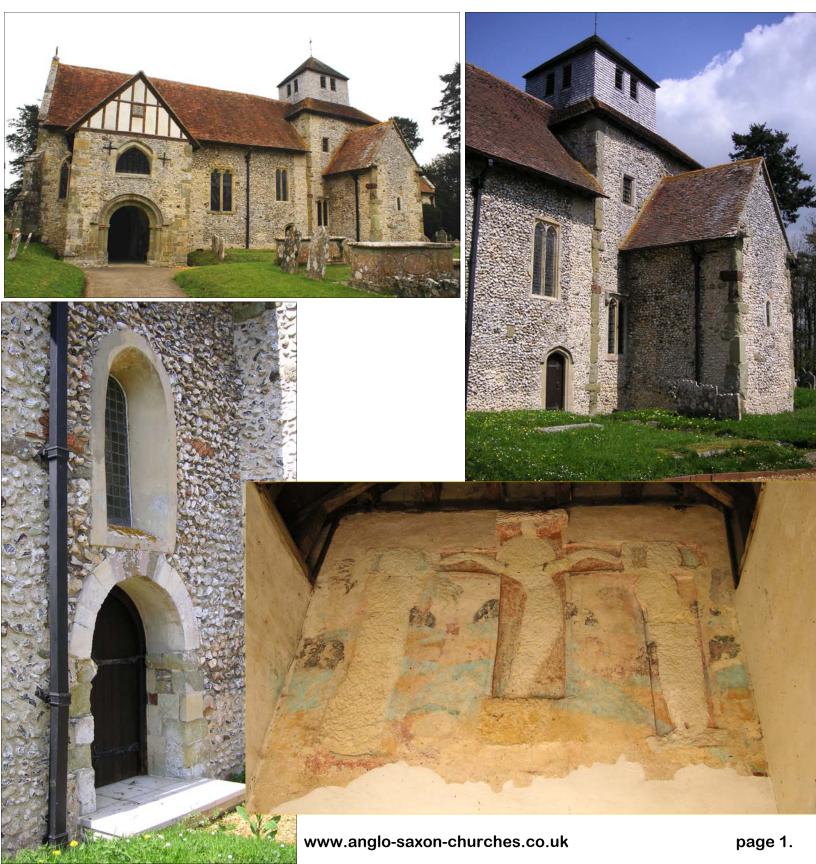
- 1. General view from south, showing part timbered S porch.
- 2. Tower, part of nave and south 'porticus' from the south. Note how the porticus is less than the width of the tower, the corner of the tower walls seen rising clear of the adjunct. Note also that the tower is the same width as the nave
- 3. Rood (defaced) on exterior S face of nave wall, seen from within the south porch.
- 4. Doorway with double splay window above, E wall, S porticus.

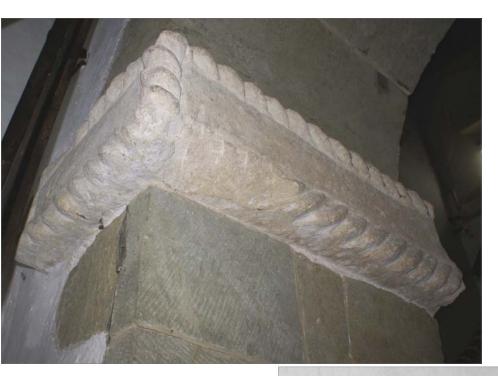
5. Detail of monolithic W impost, south archway of tower; with cable decoration (archway gives access to S porticus from tower).

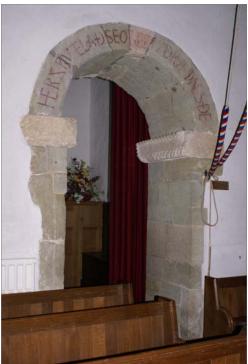
6. General view (from tower) of S archway, the only remaining from the original 4 inside the tower. From the form of the letters a date in the second decade of the eleventh century has been arrived at.

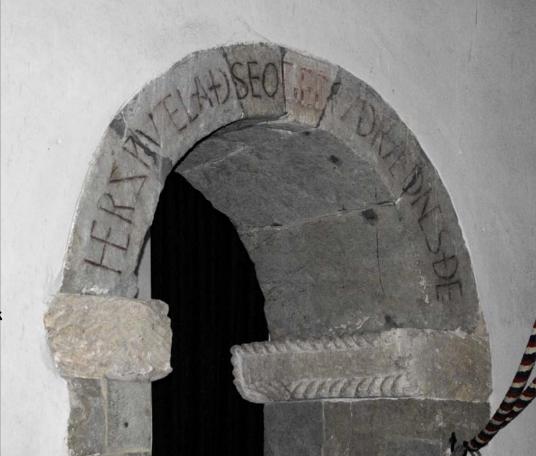
7. Detail of the inscription over the archway. Translated it reads "Here is manifest the Word to thee."

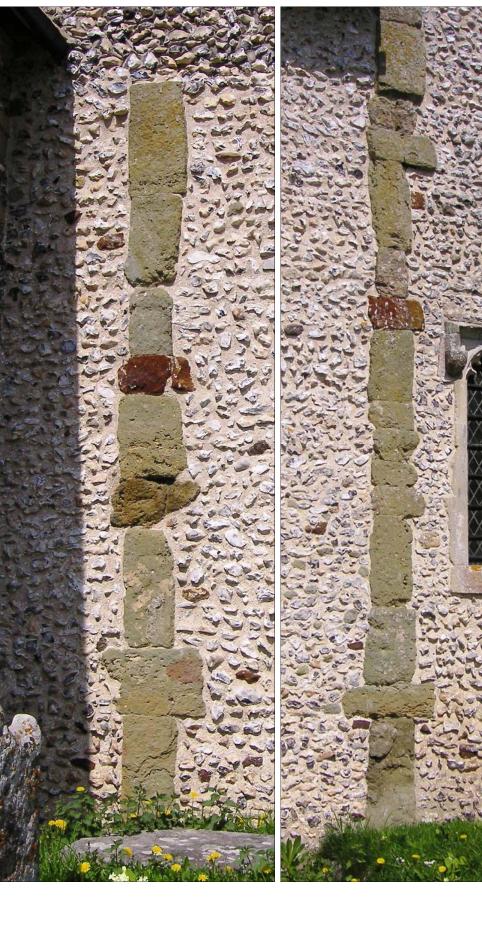
8. Pilaster situate south wall of nave and a little to east of E wall of porch.

9. SW quoin of tower where tower adjoins nave (tower to right).

Note: the pilasters and quoins, laid in irregular long-and-short technique, are of the type where the finished pilaster appears as a raised rib cut on the face of stones which are otherwise only roughly dressed, and are appreciably wider than the pilaster itself. Doubtless the walls were rendered in the usual way and this rendering was carried up to the edge, or outstand, of the pilaster strips.

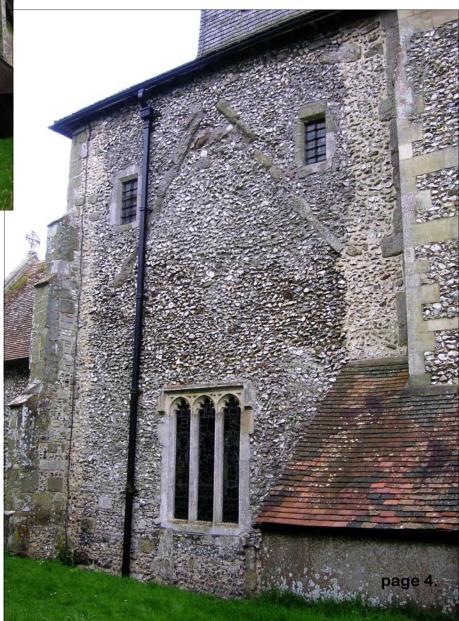
10. Chancel & tower from ENE, note the original roof line extant on the east face of the tower, above the present chancel roof. The Saxon chancel therefore has been lowered.

Note (in picture 10) the form of the roof of the tower which probably represents (and noted now only from descriptions) major towers that have vanished, such as those at the cathedrals at Selsey (Sussex) and Winchester (Hants).

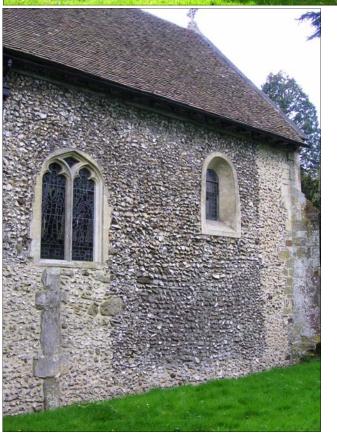
11. The pitch of the roof of the north porticus as seen against the north face of the tower (do not be confused by the more modern stonework to the very right of the photo, this is a Victorian chimney

rising from the boiler-house). The NE quoin of the tower has been in large part destroyed due to the medieval buttress (which seen in both photos).

12. Western part of N wall of nave, showing truncated pilaster strip, and also a double splayed window which is one of two in this wall.

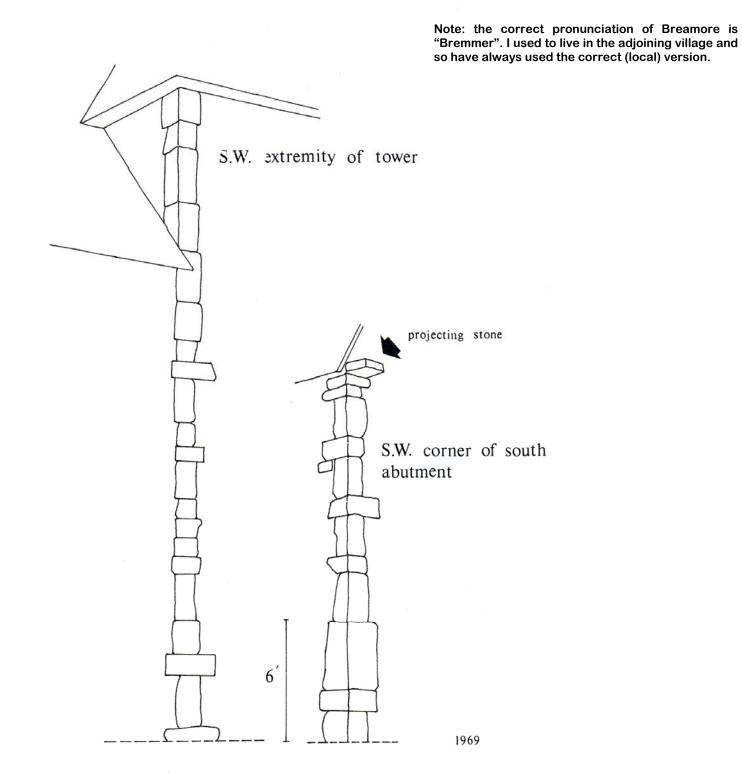
Detail of 'pilaster strip' at the meeting of nave and tower (south wall), and seen to the right the SW quoin of the transept or porticus, illustrating long & short work.
