Church of All Saints, Netheravon, Wilts.

All pictures viewed clockwise from top left. This page -

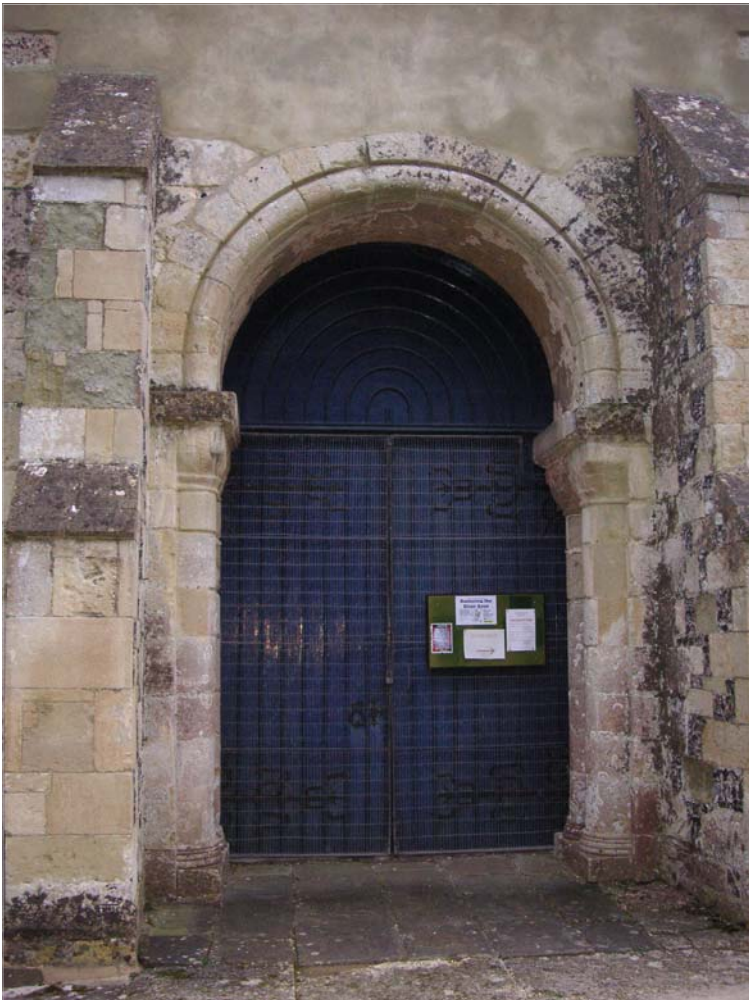
1. West archway, tower, viewed from W.
2. Blocked doorway in N wall tower.
3. The tower viewed from SW.
4. Detail of the RH capital, seen in photo 1.

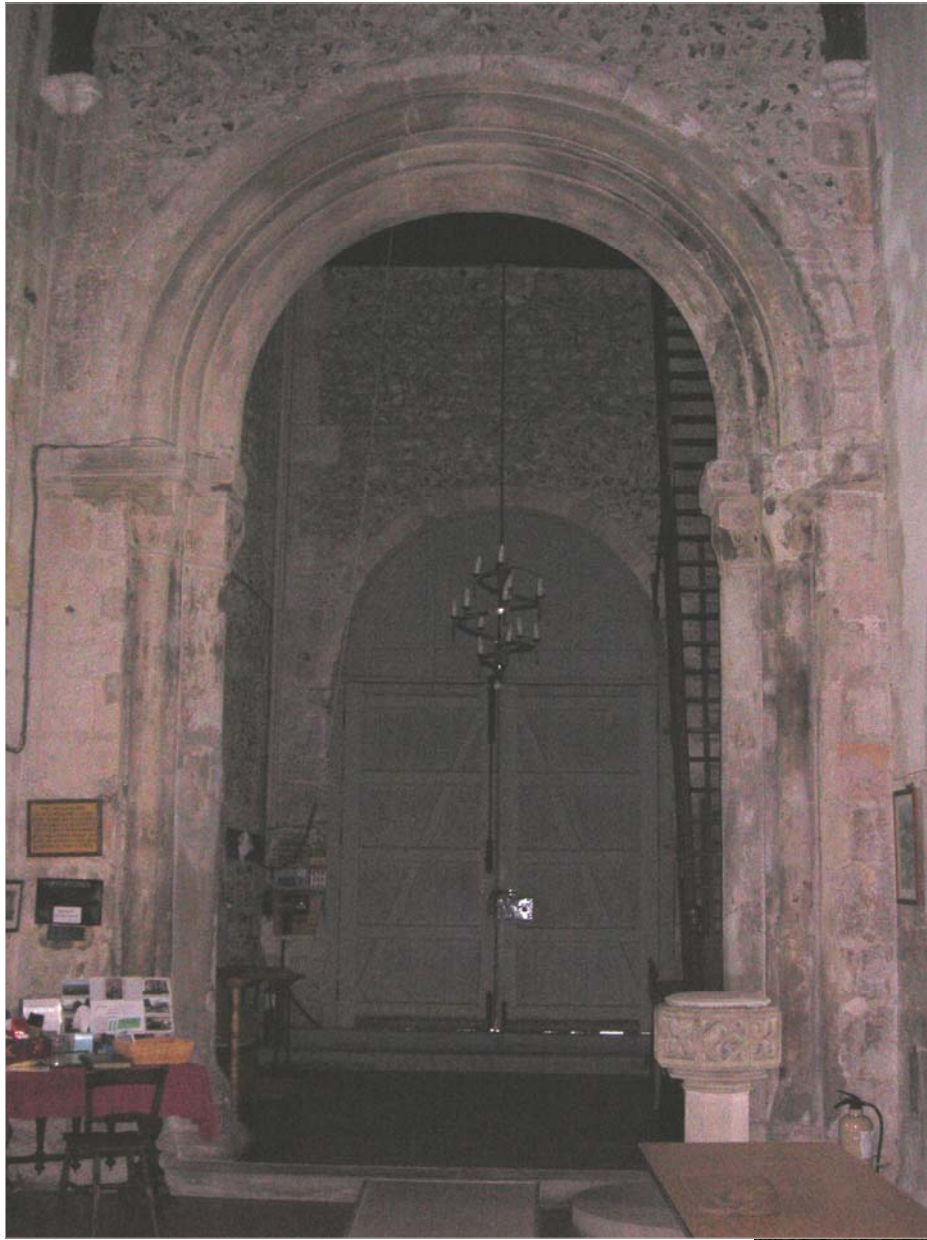
3. East tower archway, viewed from the east, in nave (nave is set to the east of the tower). This archway is different in detail, and larger, compared to its western sister (see page 1) and shows signs of heavy repair (in places) in plaster. Date, possibly transitional Saxo-Norman.
4. The arched opening in the east wall of the tower (seen from the nave) and situate above the arch in photo 1.
