www.anglo-saxon-churches.co.uk

All Saints Church, Brixworth, Northants.

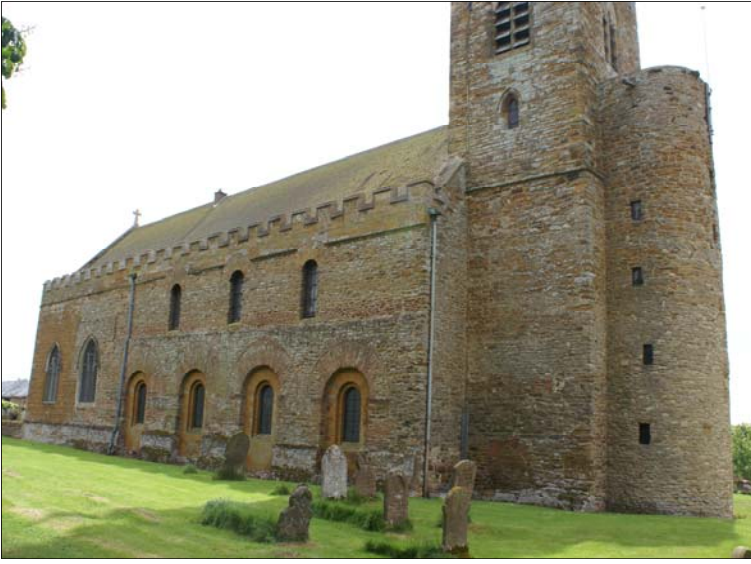
1. The exterior from the north aspect.
2. The interior of the nave looking west, showing the now blocked arches which originally led to a series of 'porticus' or side chapels.
3. The west wall of the nave in more detail, showing the doorway above cut through by the 10th c. triple window above that.
4. Doorway in south wall of tower.
5. South aspect of tower.
6. The east end of the (present) nave showing the archway to the chancel (chancel rebuilt and restored in the 19th cent.)
