Church of St John, Milborne Port, Somerset.

Milborne Port church.

Milborne Port church; chancel.

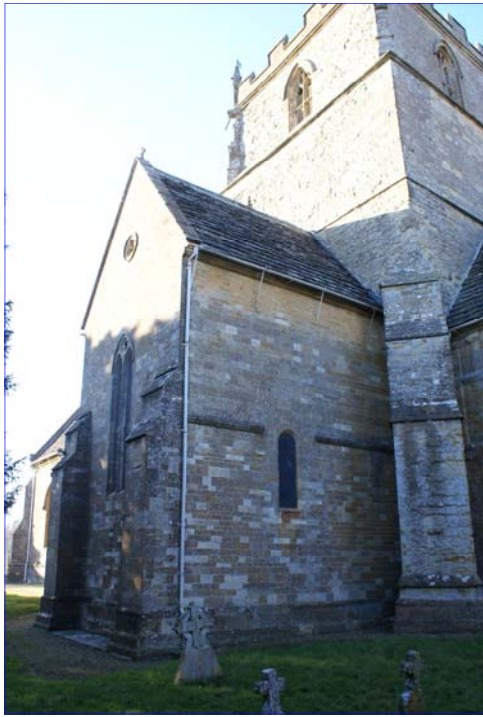
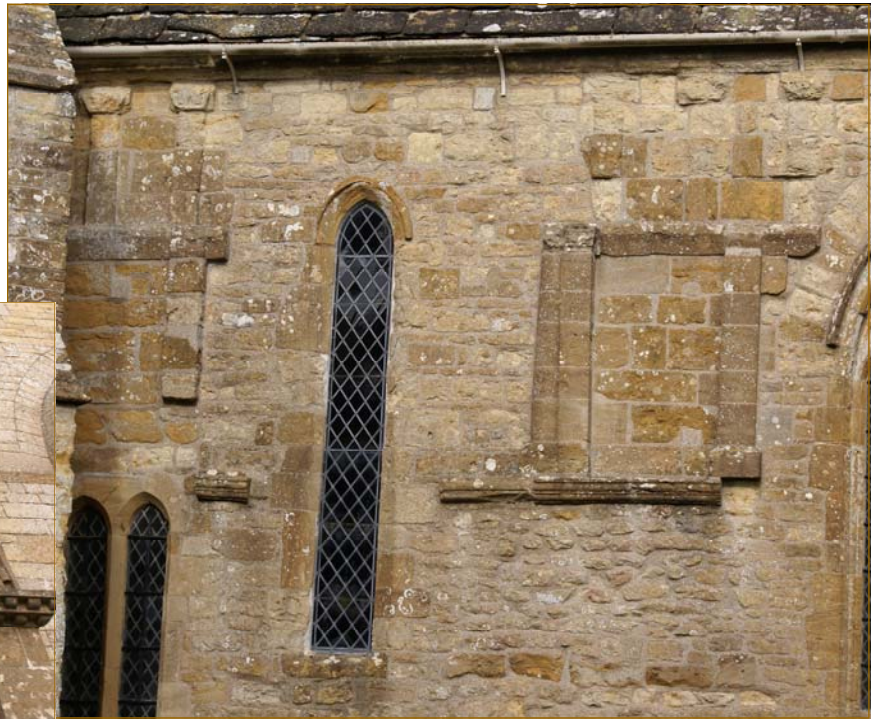
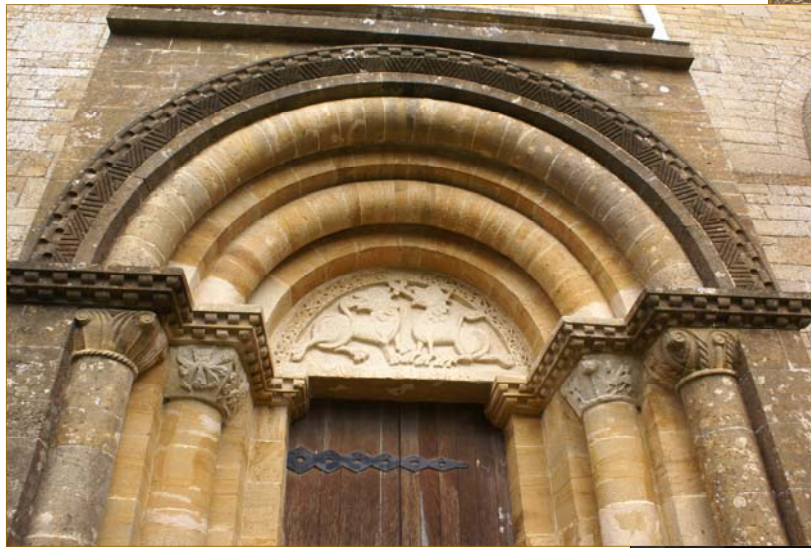
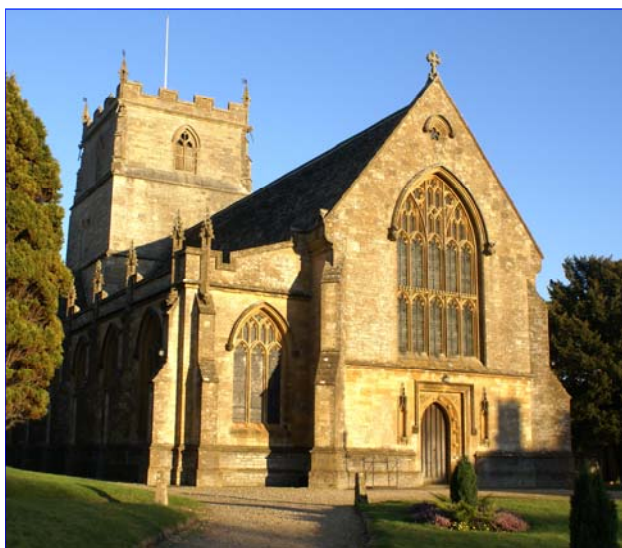
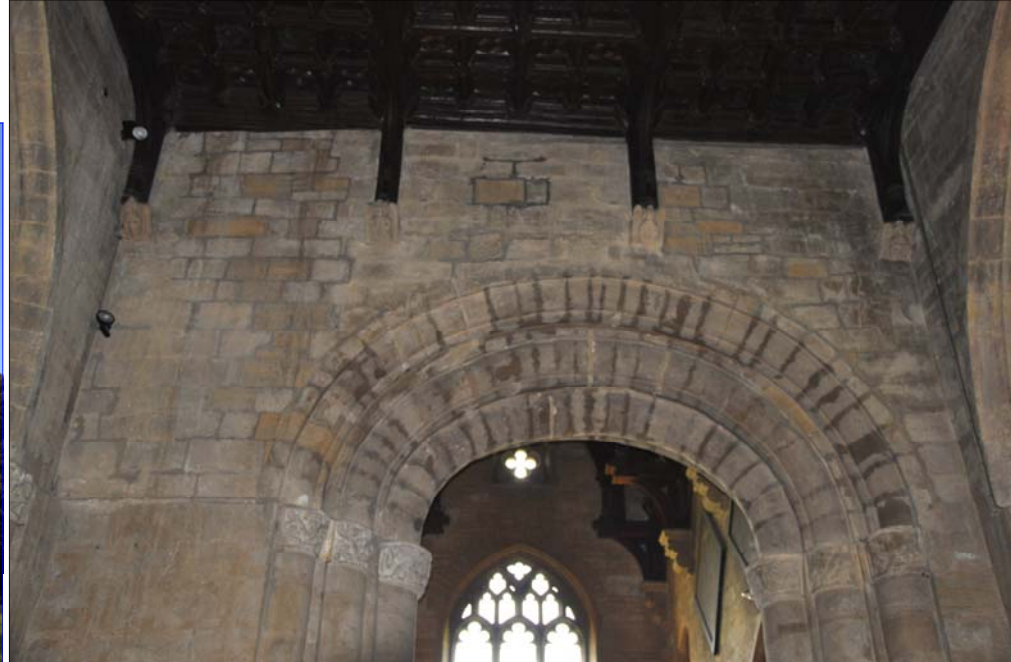
Clockwise from top left, this page -

1. Central tower and S 'transept' from the SE. Note the characteristic 'narrower' adjunct to the tower (as at Wimborne Minster, Breamore, and at Sherborne Abbey).
2. South wall of chancel showing surviving pilaster strips/arcading.
3. North tower arch, giving access to transept, viewed from inside crossing.
4. General view of church from W, showing Victorian nave, and the central tower.
5. Restored S doorway to nave; the outer order in darker stone is of Victorian date.

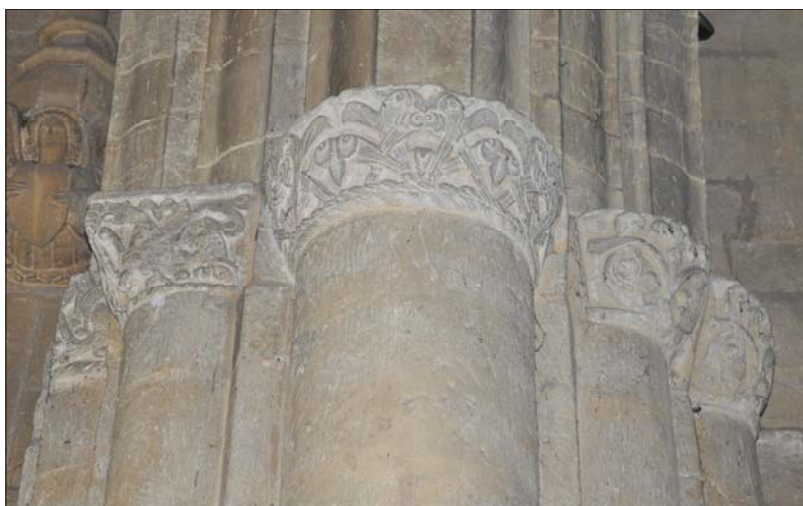
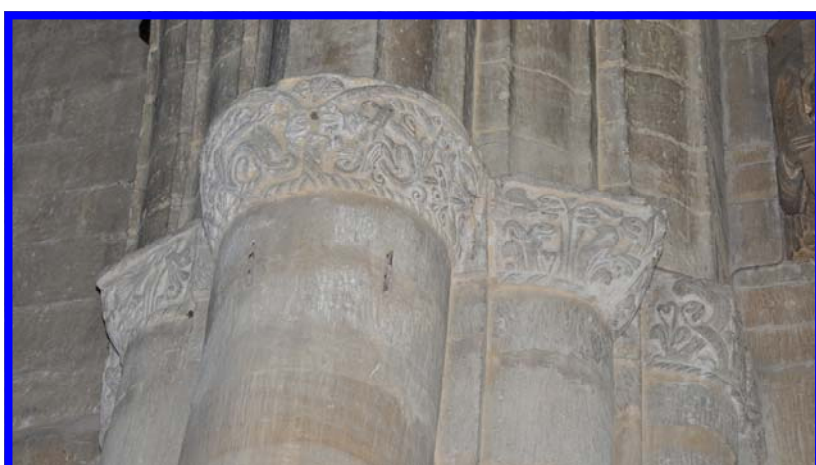
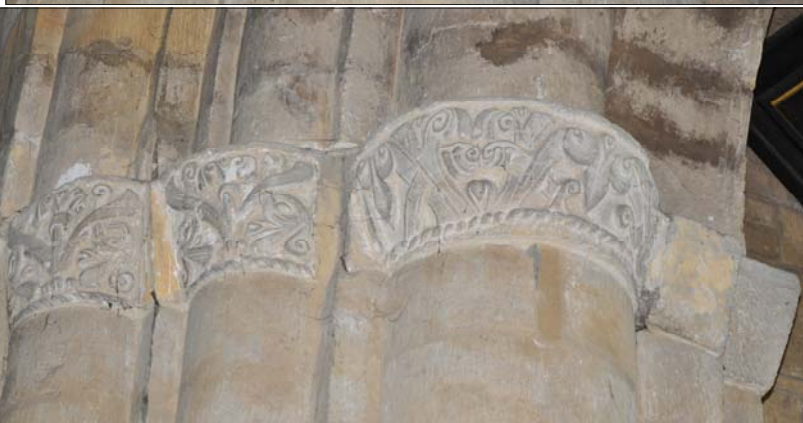
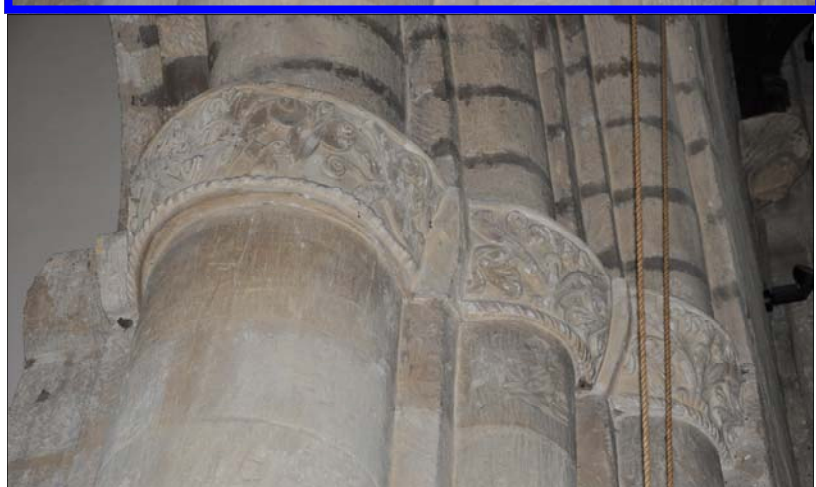
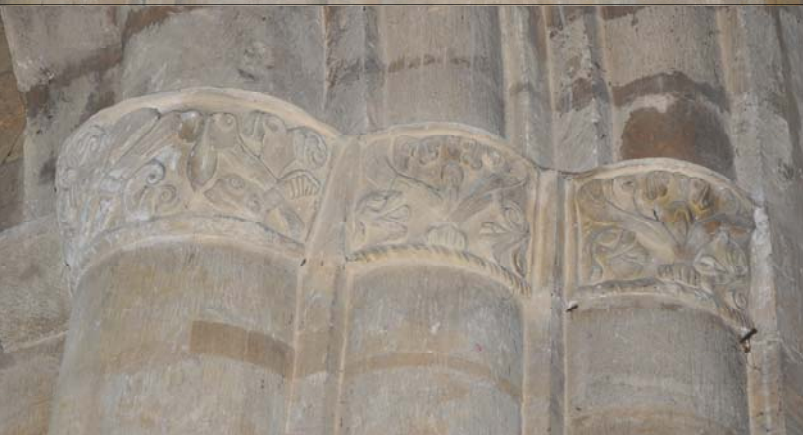
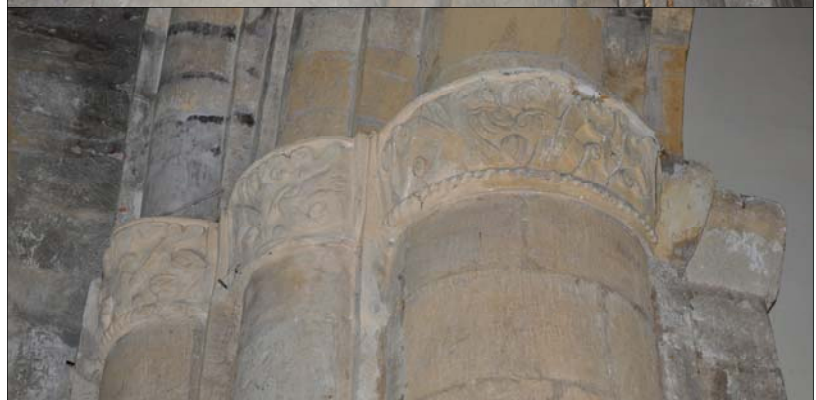
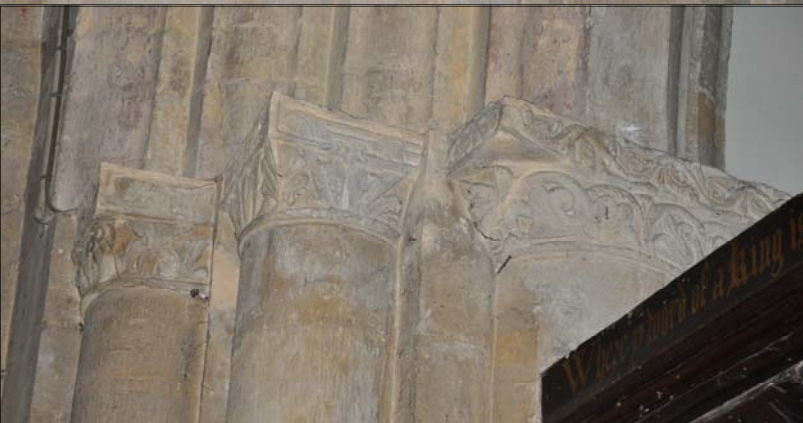
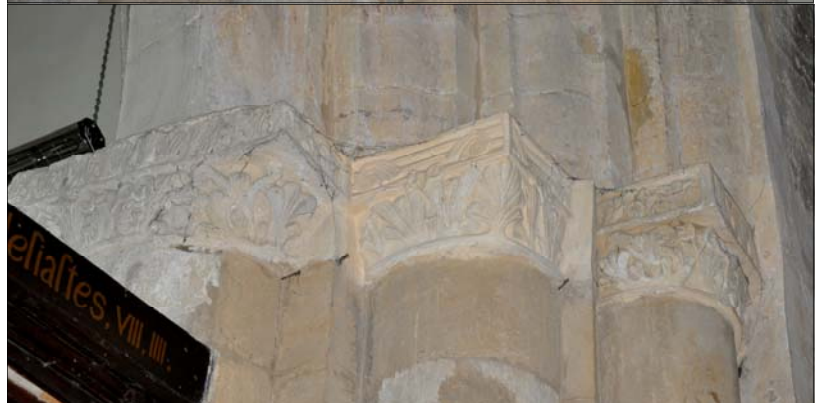
From top right, clockwise, this page -

Capitals, tower crossing; first photo (with blue border) is at SW corner, then moving anti-clockwise around the crossing, thus featuring all eight capitals in strict order.

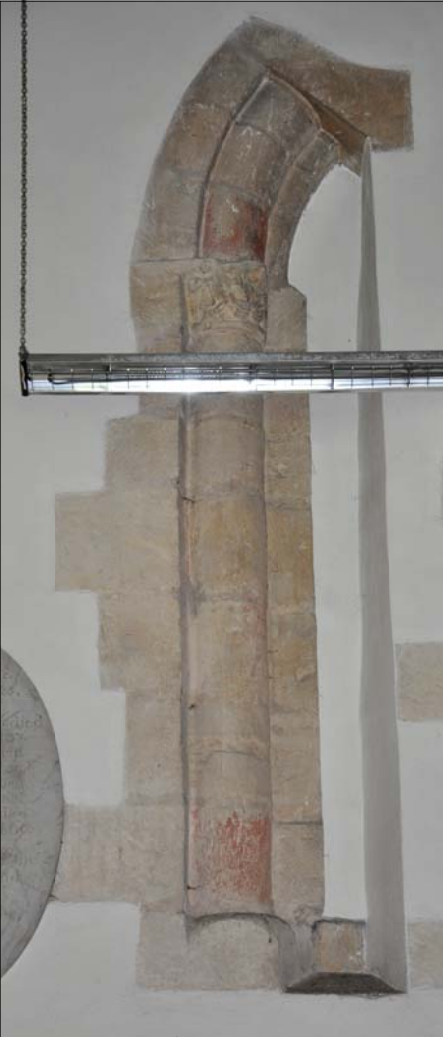
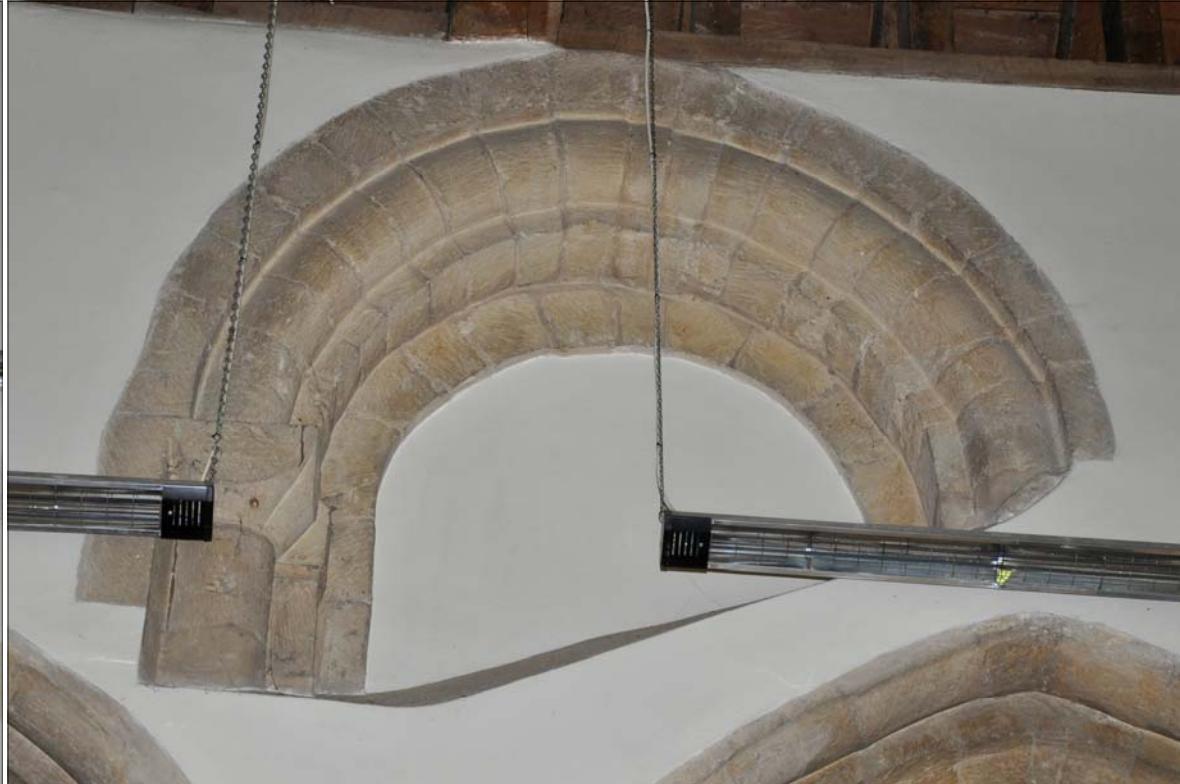
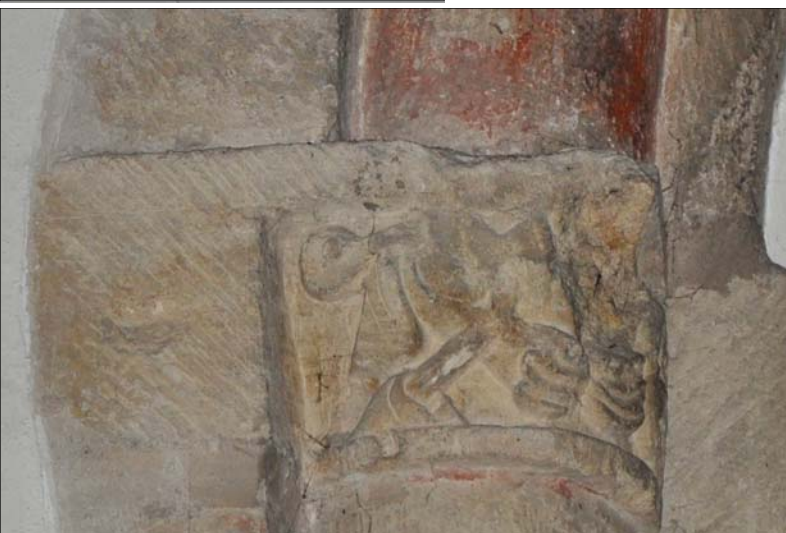
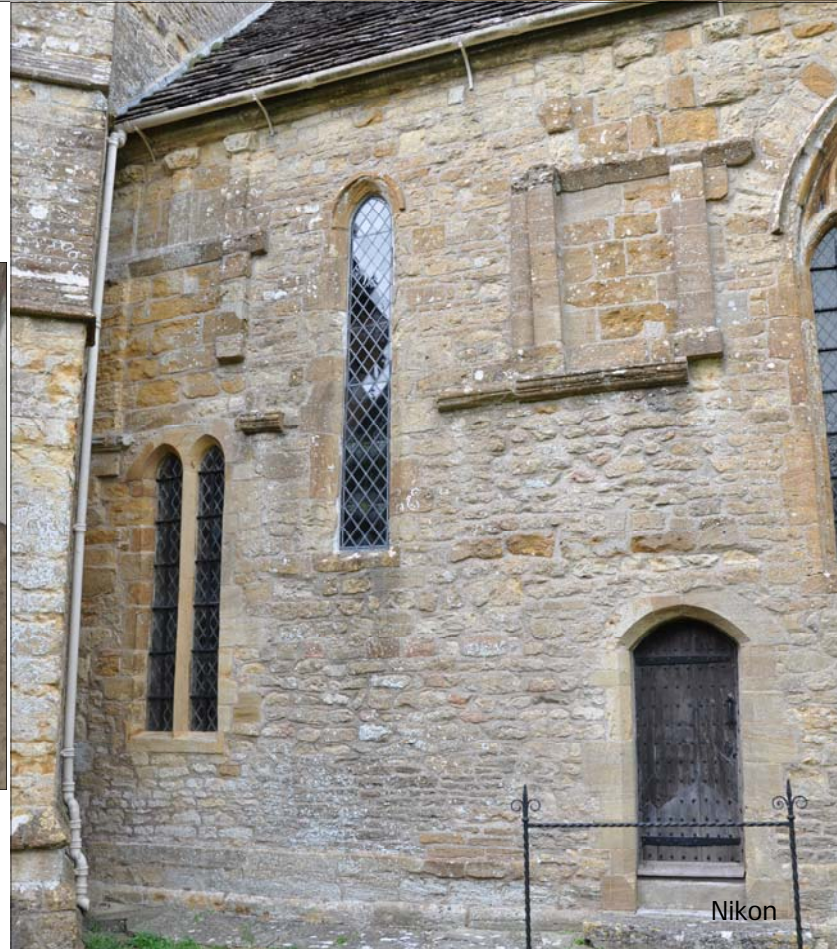
This page from top left; in clockwise order.

1. South wall, blocked Saxon window with motifs in similar manner to crossing capitals, viewed internally (partly obstructed by heater!).
2. North wall, blocked Saxon window (note non-radial voussoirs), this with 'mature' Continental Romanesque cushion capital (poorly placed heaters intrude again in this picture).
3. A reminder of how the disturbed work appears on the exterior of the south wall (see H.Taylor, 'Anglo-Saxon Architecture' Vol. I, page 427, for explanation).
4. Closer detail of decorated capital seen in picture 1.
