## Church of St. Peter, Britford, Wilts.

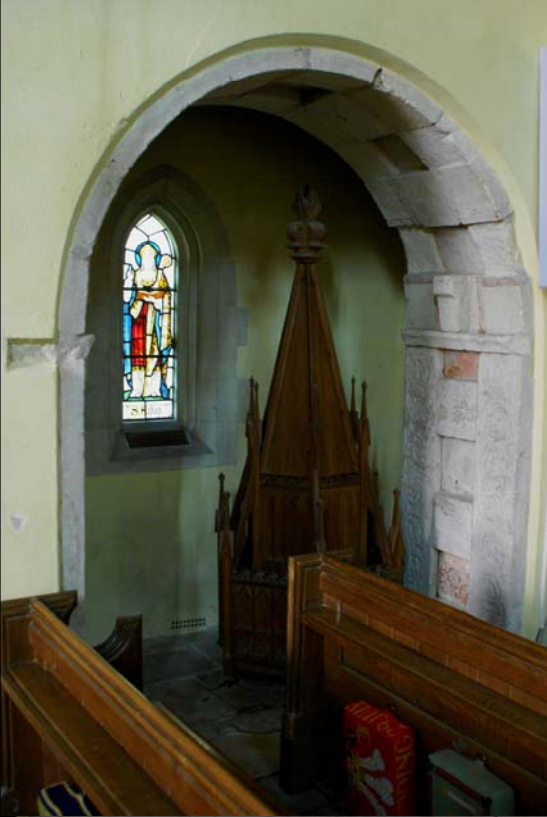
1. North archway.
2. East jamb of same; note that the vertical stones are in one piece, and this 'design' of grapes, or a vine, is found illustrated, albeit in more elaborate form, in Prof. Banister Fletcher's book "A History of Architecture" pg 67 illus. F. under the heading "Roman Ornament. 1."
3. Detail of Roman mouldings in pic 2. Note this stone has been shortened at the top, to 'fit' its new site, or perhaps the 2 vertical stones were one and are sawn in two?
4. South archway, which comprises a far higher Roman tile content than stone 'tile'.
5. A detail of impost of north arch and its make up.
6. Base of the west impost of the north archway, note the Roman mouldings, used like a skirting board. It is as if the builder has been presented with a pile of stone and asked to make 2 archways. Its not a bad job considering!
