This picture file covers chancel, tower & crossing arches, doorways, windows, stairways, and detail.

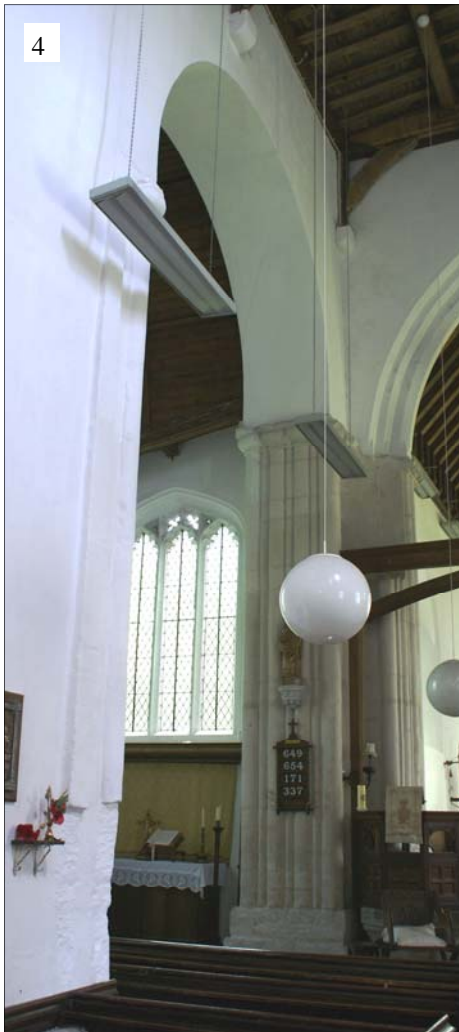
1. [St. Mary Minster, Stow, Lincs](#); the chancel arch from east.
2. [St. Mary, Sompting, W. Sussex](#); the tower arch from the nave.
3. [Church of All Saints, Brixworth, Northants](#); the chancel arch and associated windows viewed from the west.

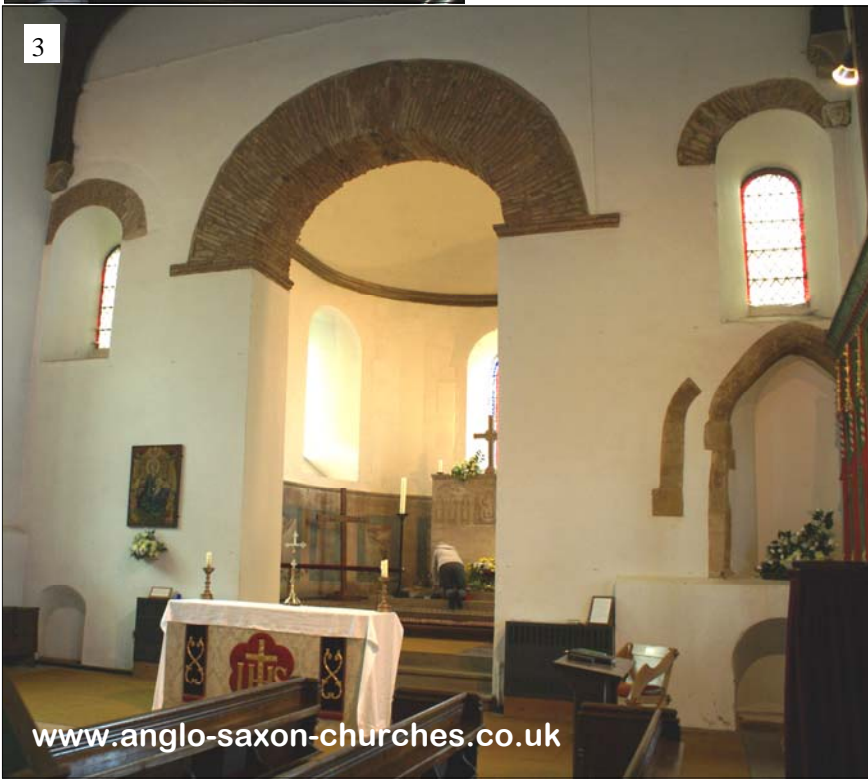
4. [Holy Trinity church, Great Paxton, Hunts](#); remains of crossing; on the left is the north transept arch, to the right remains of the chancel archway (the nave archway has been totally removed). Of the Saxon tower there is now no trace above eave level.

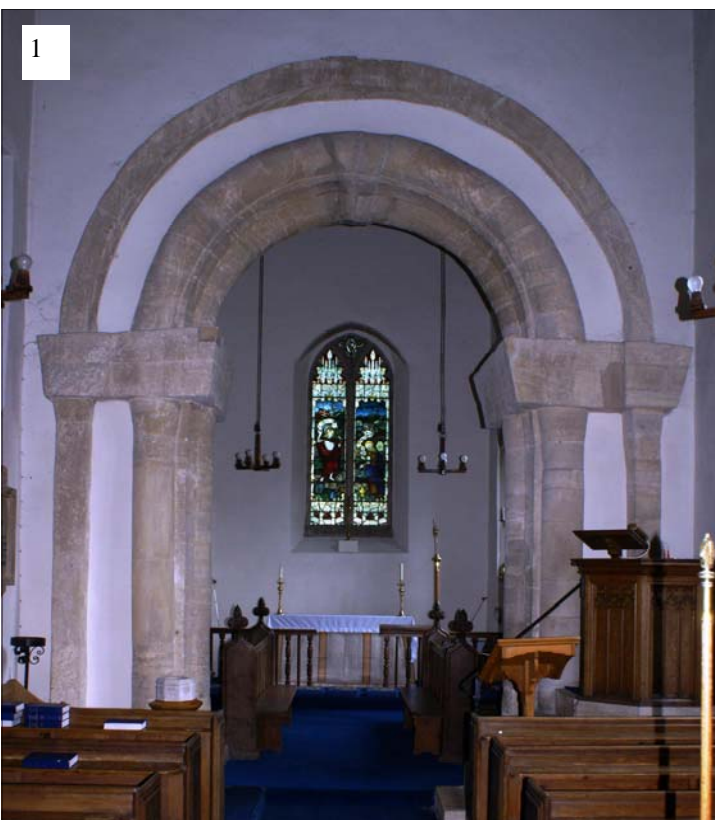
1. Chancel arch from west.
2. South impost and springing of arch, and showing 'outer pilaster in square section.
3. Chancel arch viewed from the chancel.

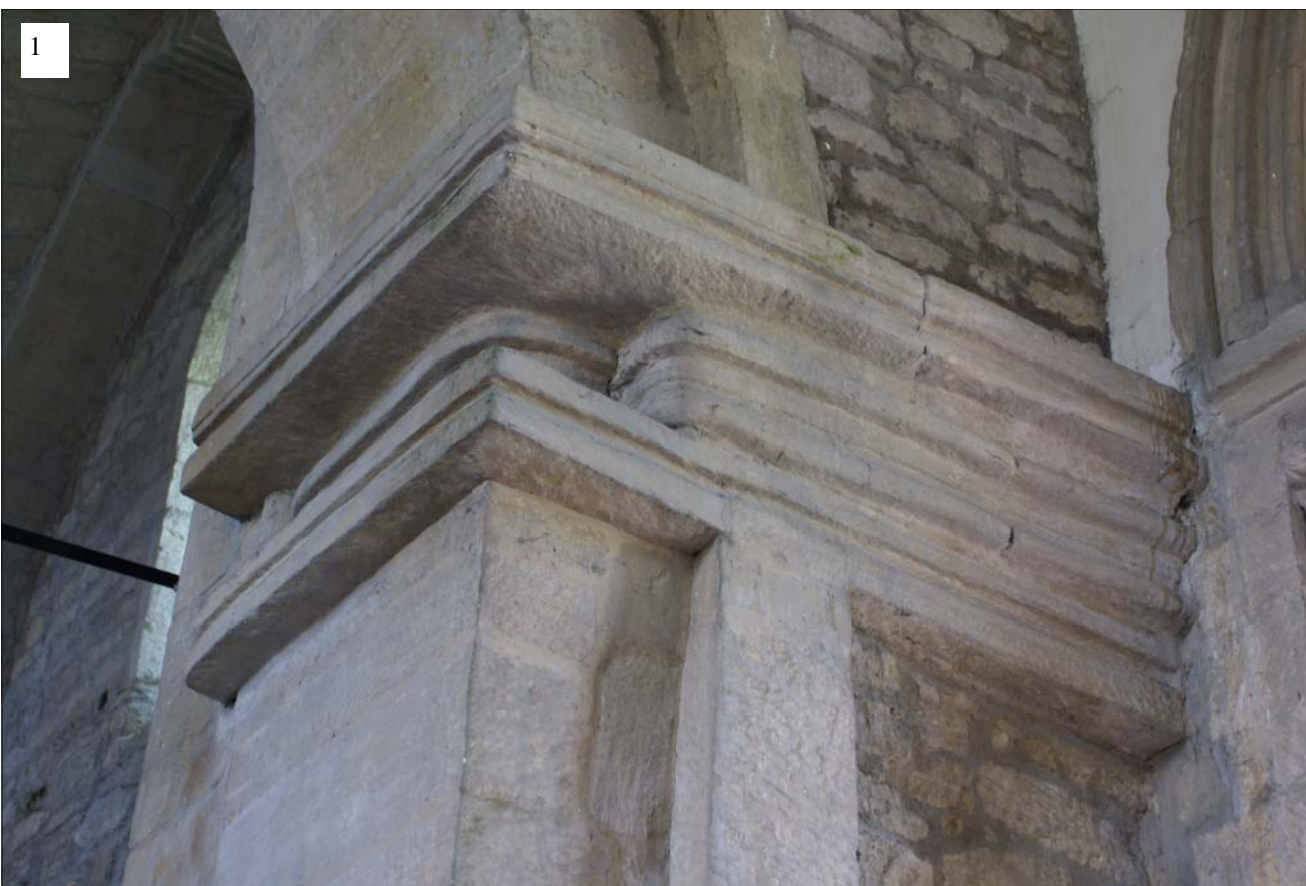
1. Tower archway showing curious 'sandwich' type construction of (north) impost.
2. The archway viewed from the nave.
3. As picture 1, but viewed from a different (lower) angle.

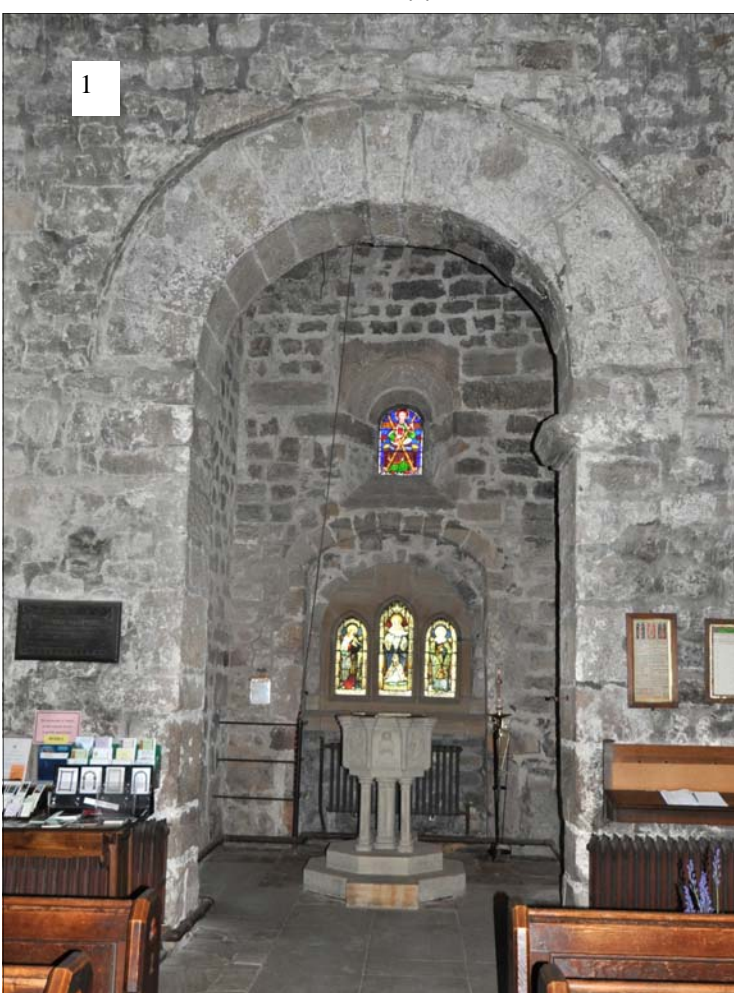
1. Reused Roman; tower archway at St. Andrews church, Corbridge, Northumberland (no doubt from nearby Corstopitum). Note the first set of stones (left and right) above the impost are wrongly placed since they are not tapered, they belong below the imposts (obviously the numbering of the kit of Roman parts went wrong!). This gives the arch a curious stilted appearance. Dimensions 8ft 2in. wide and 16ft 3in. high.

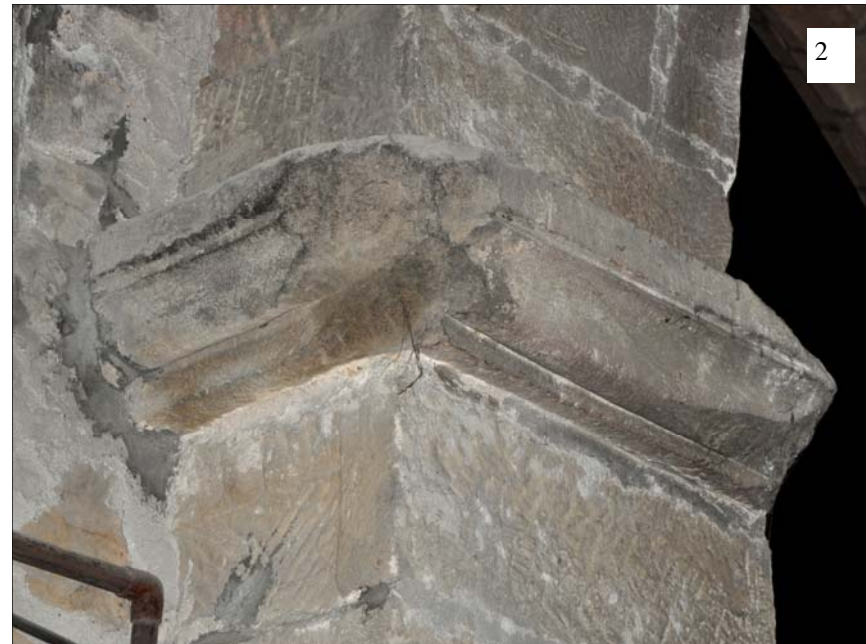
2. North impost of arch, seen from inside the tower. The damage may have occurred during removal, or in later times.
3. West window in ground stage of tower, viewed internally.
4. St. Paul, Jarrow, Co. Durham. Triangular headed doorway in monastery buildings, in west wall (which runs north/south) and seen from W.
