Cathedral church at North Elmham, Norfolk. Dedication unknown.

Ruins of a complete church, consisting of a west axial tower with south turret-stair; a nave flanked by two small towers; transepts; and a small apsidal chancel; period 1000 to 1050, possibly rebuilt on ruins dating from 650 to 700. For full description see H.Taylor, Anglo-Saxon Architecture, Vol. I, pp228-231; vol III pg 983. The site is somewhat complicated since it stands within a fortified earthwork of rectangular ditches and banks which may have been raised by the Danes. Bishop Henry Despenser obtained a licence in 1387 to fortify his manor at Elmham and the demolition of the apse and the addition of a 'matching' turret in the south nave wall are all of this date. The internal divisions in the nave are Despenser's work.

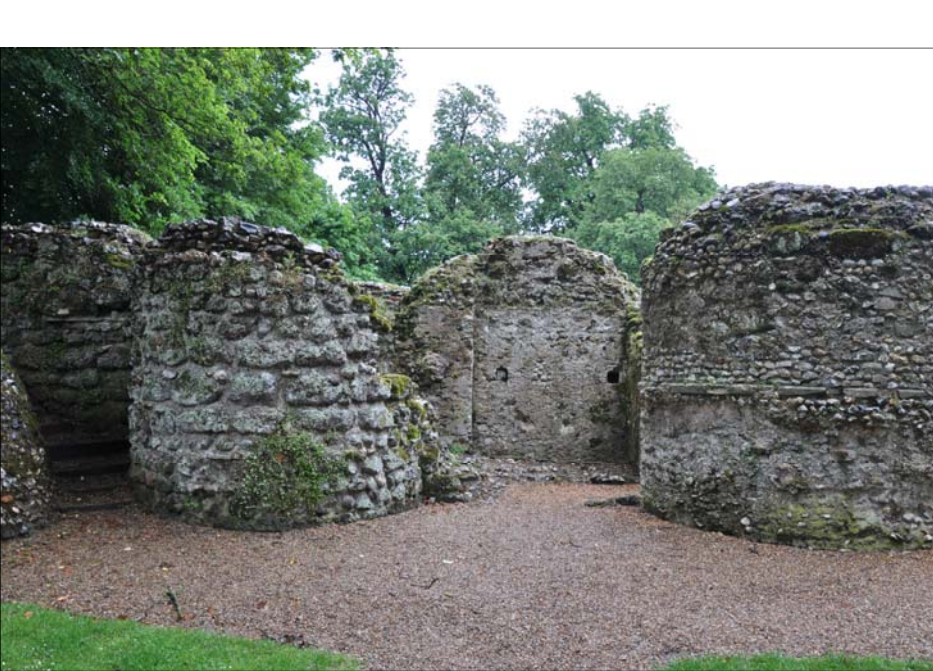
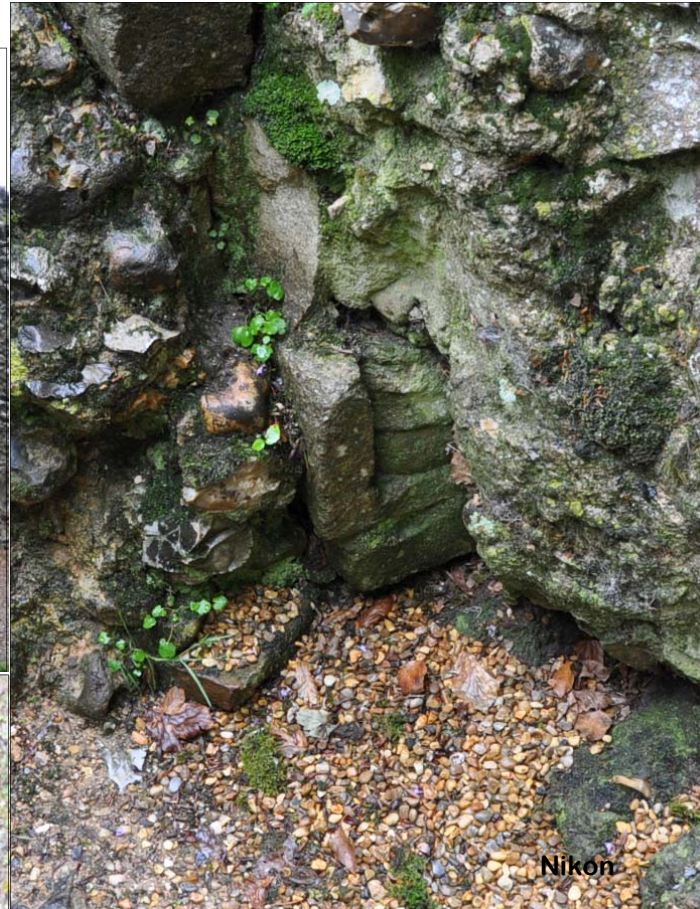
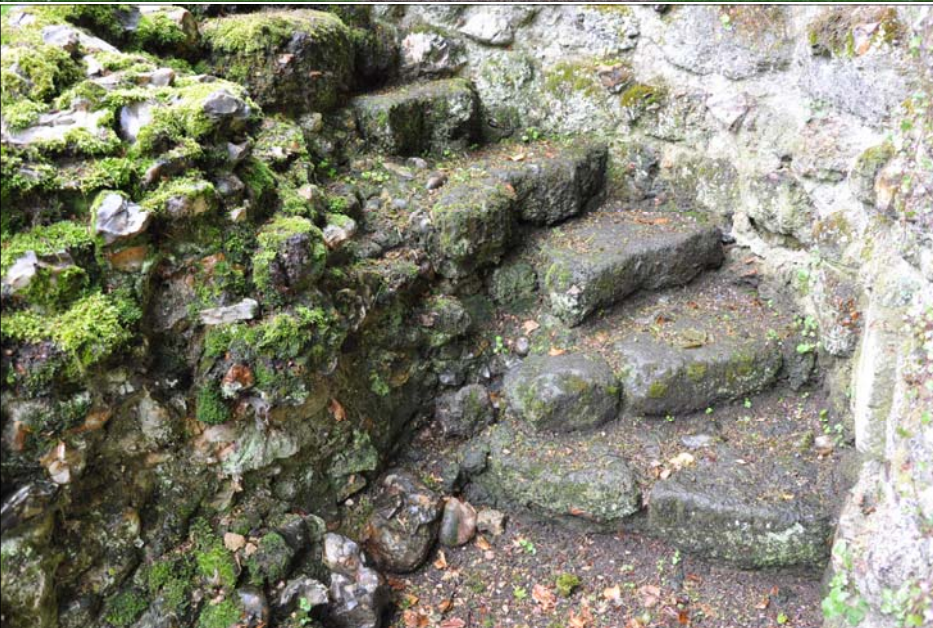
1. Looking north, left is the Saxon stair turret in the south wall of the tower, and to the right Despenser's 'copy' turret.
2. Base of easternmost column from the south nave doorway, now half hidden by Despenser's turret.
3. Remains of Saxon stairway in tower turret (the separate newel has been robbed); a typical pre-conquest construction where the treads (often made up of two or more stones) are constructed separately to the newel and notched into its curved surface. The newel is a thick cylinder (sometimes of stones 3 feet in height); this method of construction is NOT found in post-conquest work (and see similar stairways at Wimborne Minster, Broughton, Hough-on-the-Hill).

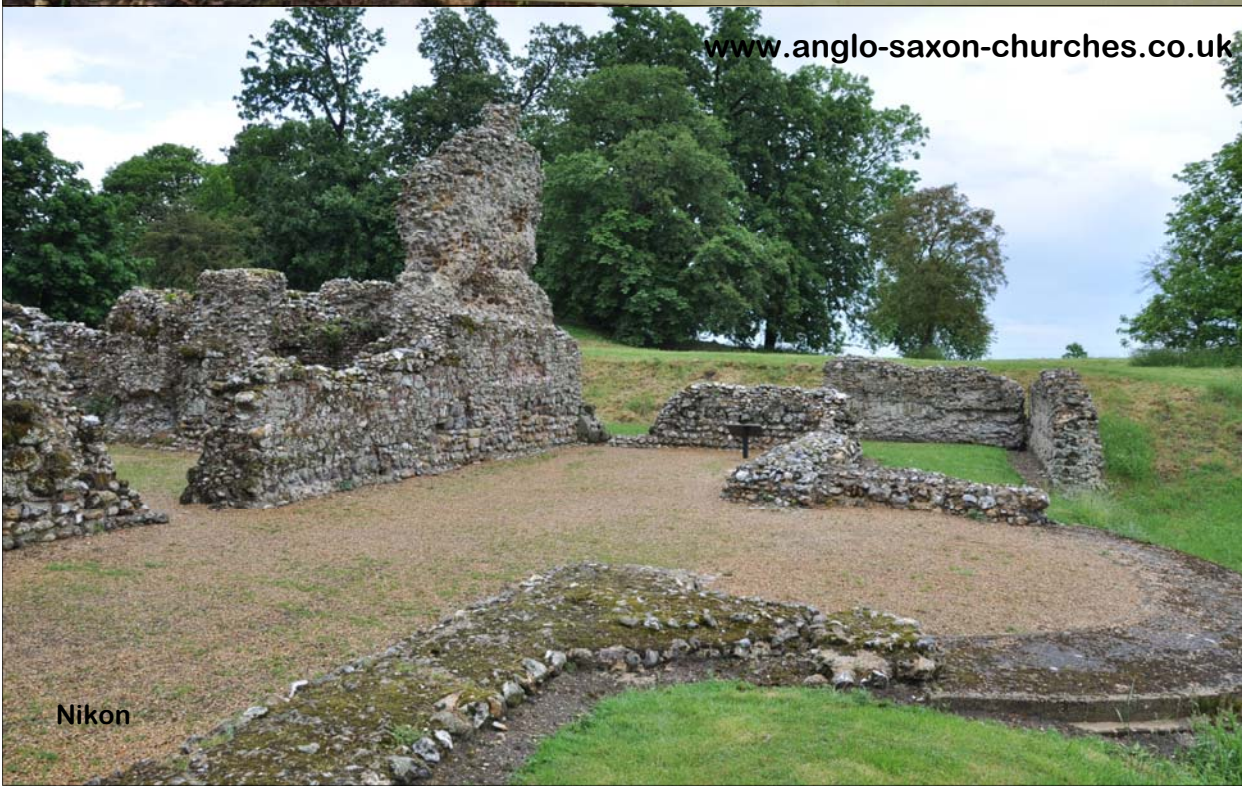
4. Explanatory text on site relating to Despenser's adaptation of the church to a fortified house, showing the 'extra' turret to the right. The actual text sadly does not reflect the antiquity of the Saxon stone church. However the plan showing the layout is useful and it shows the two towers laying immediately to the west of the transepts, and the western tower abutting the nave.
5. The foundations of the apse and attendant cross work viewed from the south. The masonry belonging to the north tower stands to a height of about 18 feet.

The positions of five display panels around the site are marked on this plan. To reach the second panel, walk towards the chapel, turn right along the path and it will be found on a grassy bank ahead.

Far left
Bishop de Losinga's chapel
This is how the chapel may have looked from this position in about 1115. The south, and probably, main entrance was straight ahead. To the left is a stair turret attached to the west tower.

Left
Bishop le Despenser's castle
Around the year 1388, Bishop Henry le Despenser of Norwich turned the chapel into a small castle. The entrance was then moved up to the first floor level, and he cleverly copied the tower stair turret on the other side of the doorway to create an impressive approach. The difference in the stone work can still be seen.

In front of the castle was a drawbridge across a dry ditch. Despenser also surrounded the chapel with earthworks to make it defensible.

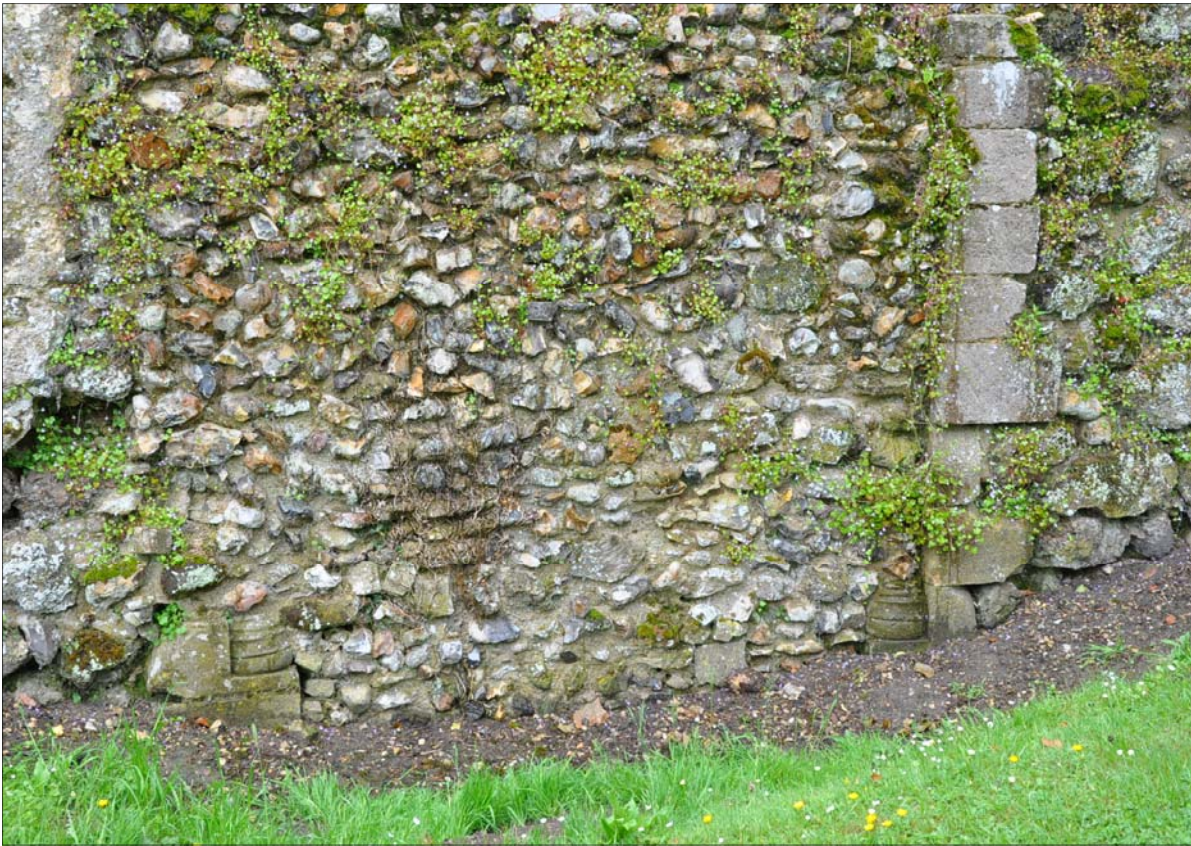
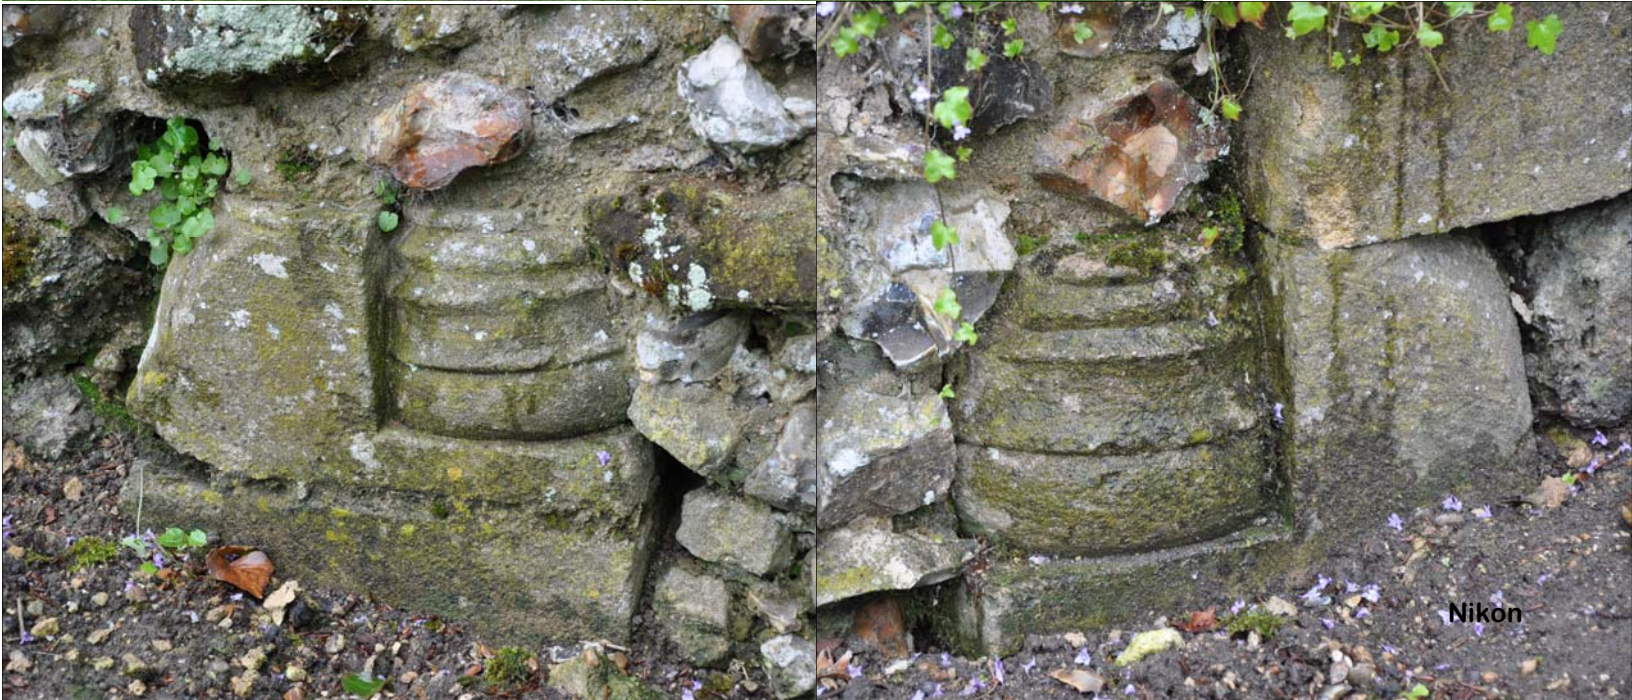
6. Blocked doorway in north wall of nave, note bases of both columns, and associated stonework.

7 & 8. Close-up of these two bases. Compare with matching base [partly obscured by Bishop Despenser's 14th century work] in pic. 2 on page 1. These base mouldings can be closely compared with the "concertina" type mouldings to be found at Stopham (Sussex) in the late Saxon capitals of the south doorway to the nave. Here we have 2 'concertinas' above the concave lower moulding (which sits upon the convex base); the top concertina is partly broken away, more so in the east base. At Stopham there are three concertinas.

I noted particularly one of the bases of the south doorway partially hidden under Despenser's medieval south turret. The base matches the pair belonging to the north nave doorway. It struck me how delicate, how petit are those mouldings, for a doorway (pictures see page 3). They agree with, and compare to, other Saxon mouldings, notably at Stopham in Sussex.

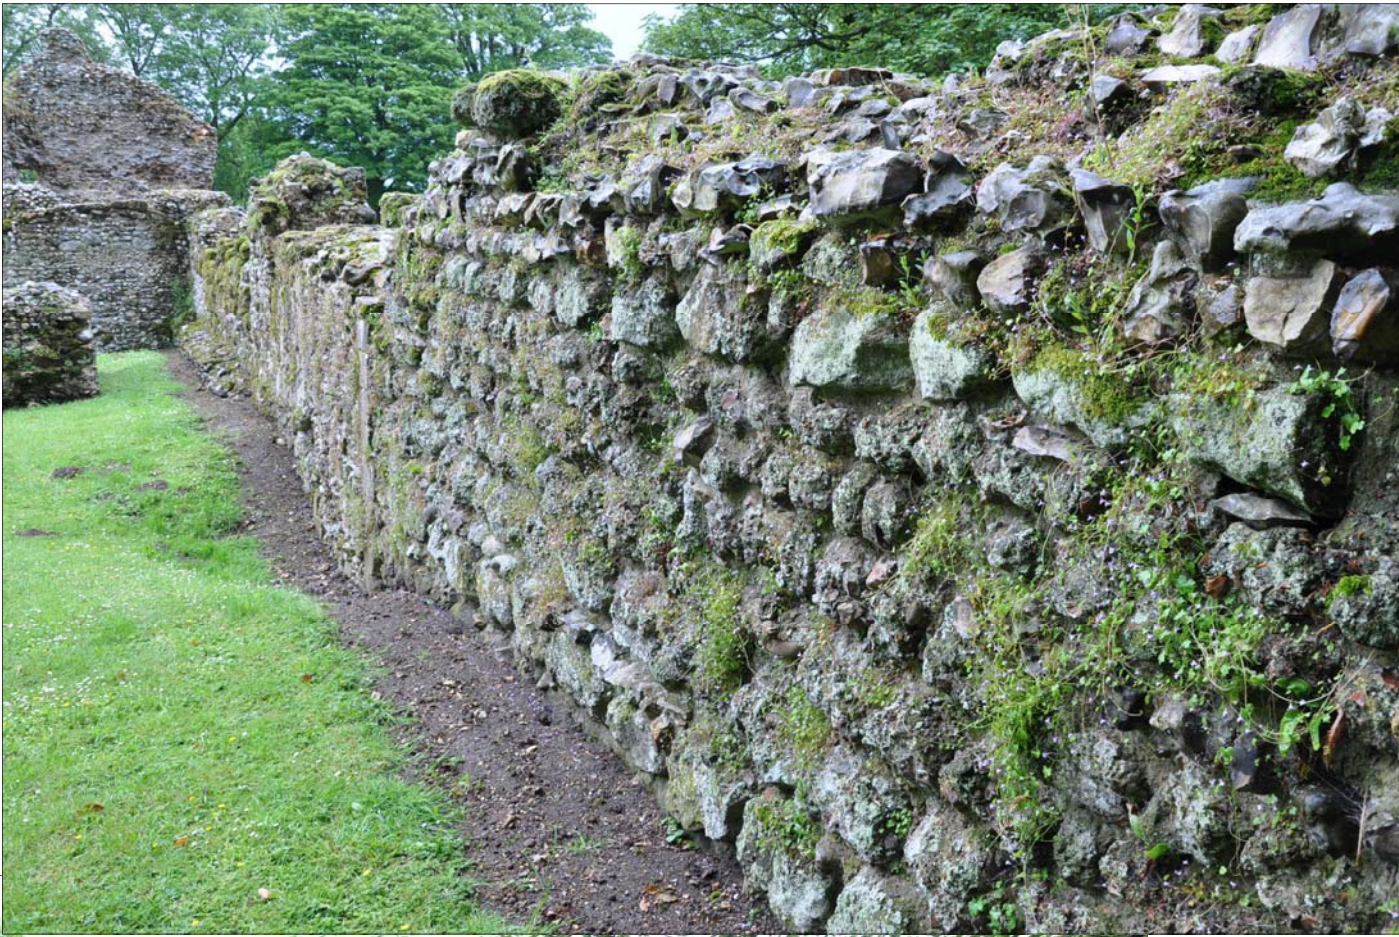
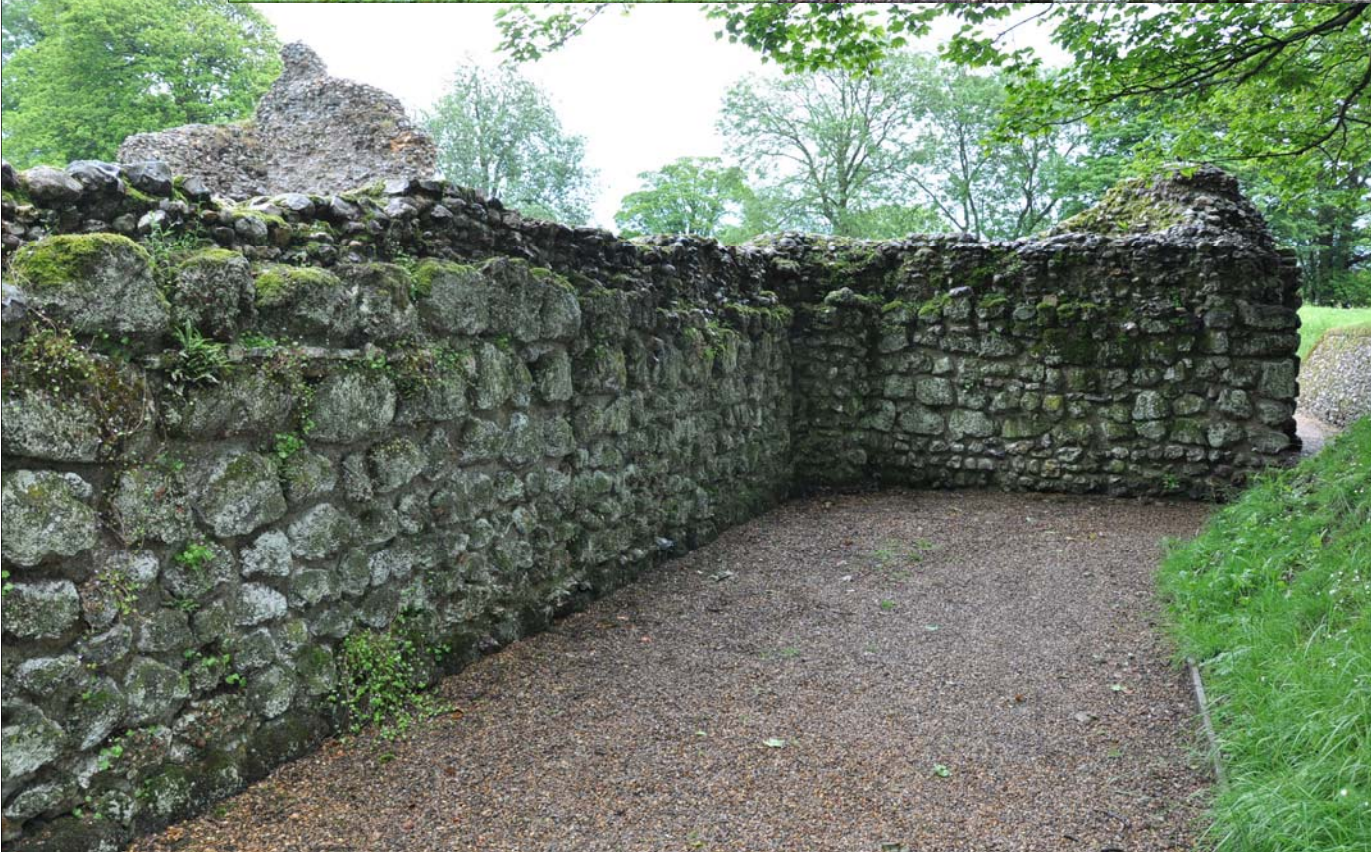
9. Run of the north wall of the nave looking east.

10. Run of south wall of nave down to the S tower (against the transept).

The walling of the church is of coursed roughly squared pieces of brown aggregate known as carstone, which stand on a well formed plinth of flint rubble (H.Taylor).
