Abbey church of St Mary, Sherborne, Dorset.

A fine building of seemingly Perpendicular style, but where the fabric under the later coverings is of a far greater age (see dedicated text page for detailed information).

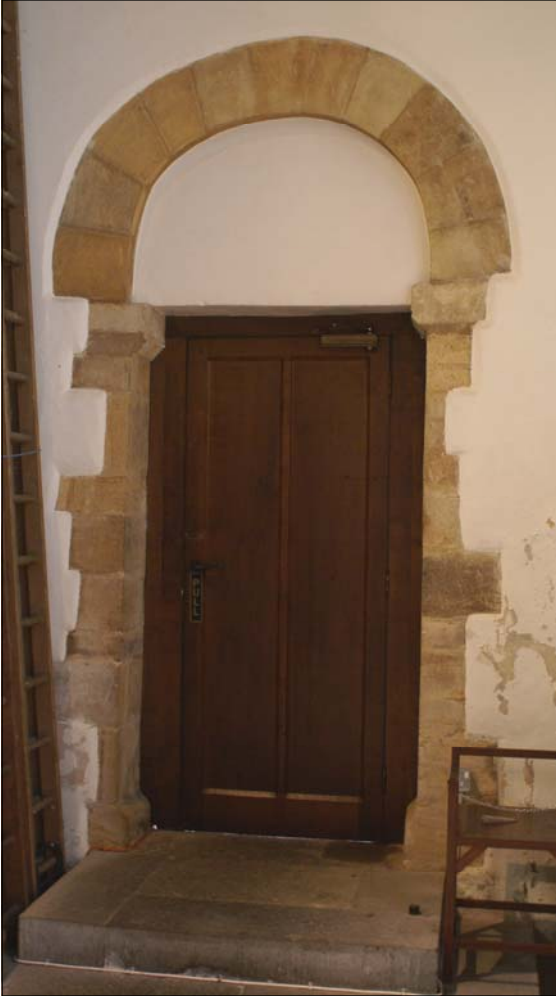
1. Saxon doorway at west end of nave N aisle, interior view.
2. Detail of abacus S capital of doorway in pic 1; note Saxon tooling (fine vertical) of dressed stones.
3. A closer detail of the west front and north aisle walling.
4. The W front from the SW (the site of the Saxon westwerken), the 'uneven' rubble work is the Saxon walling, which is extensive (see H.Taylor). Saxon work is also to be found in the N wall of the N transept up to eave level (not illustrated).

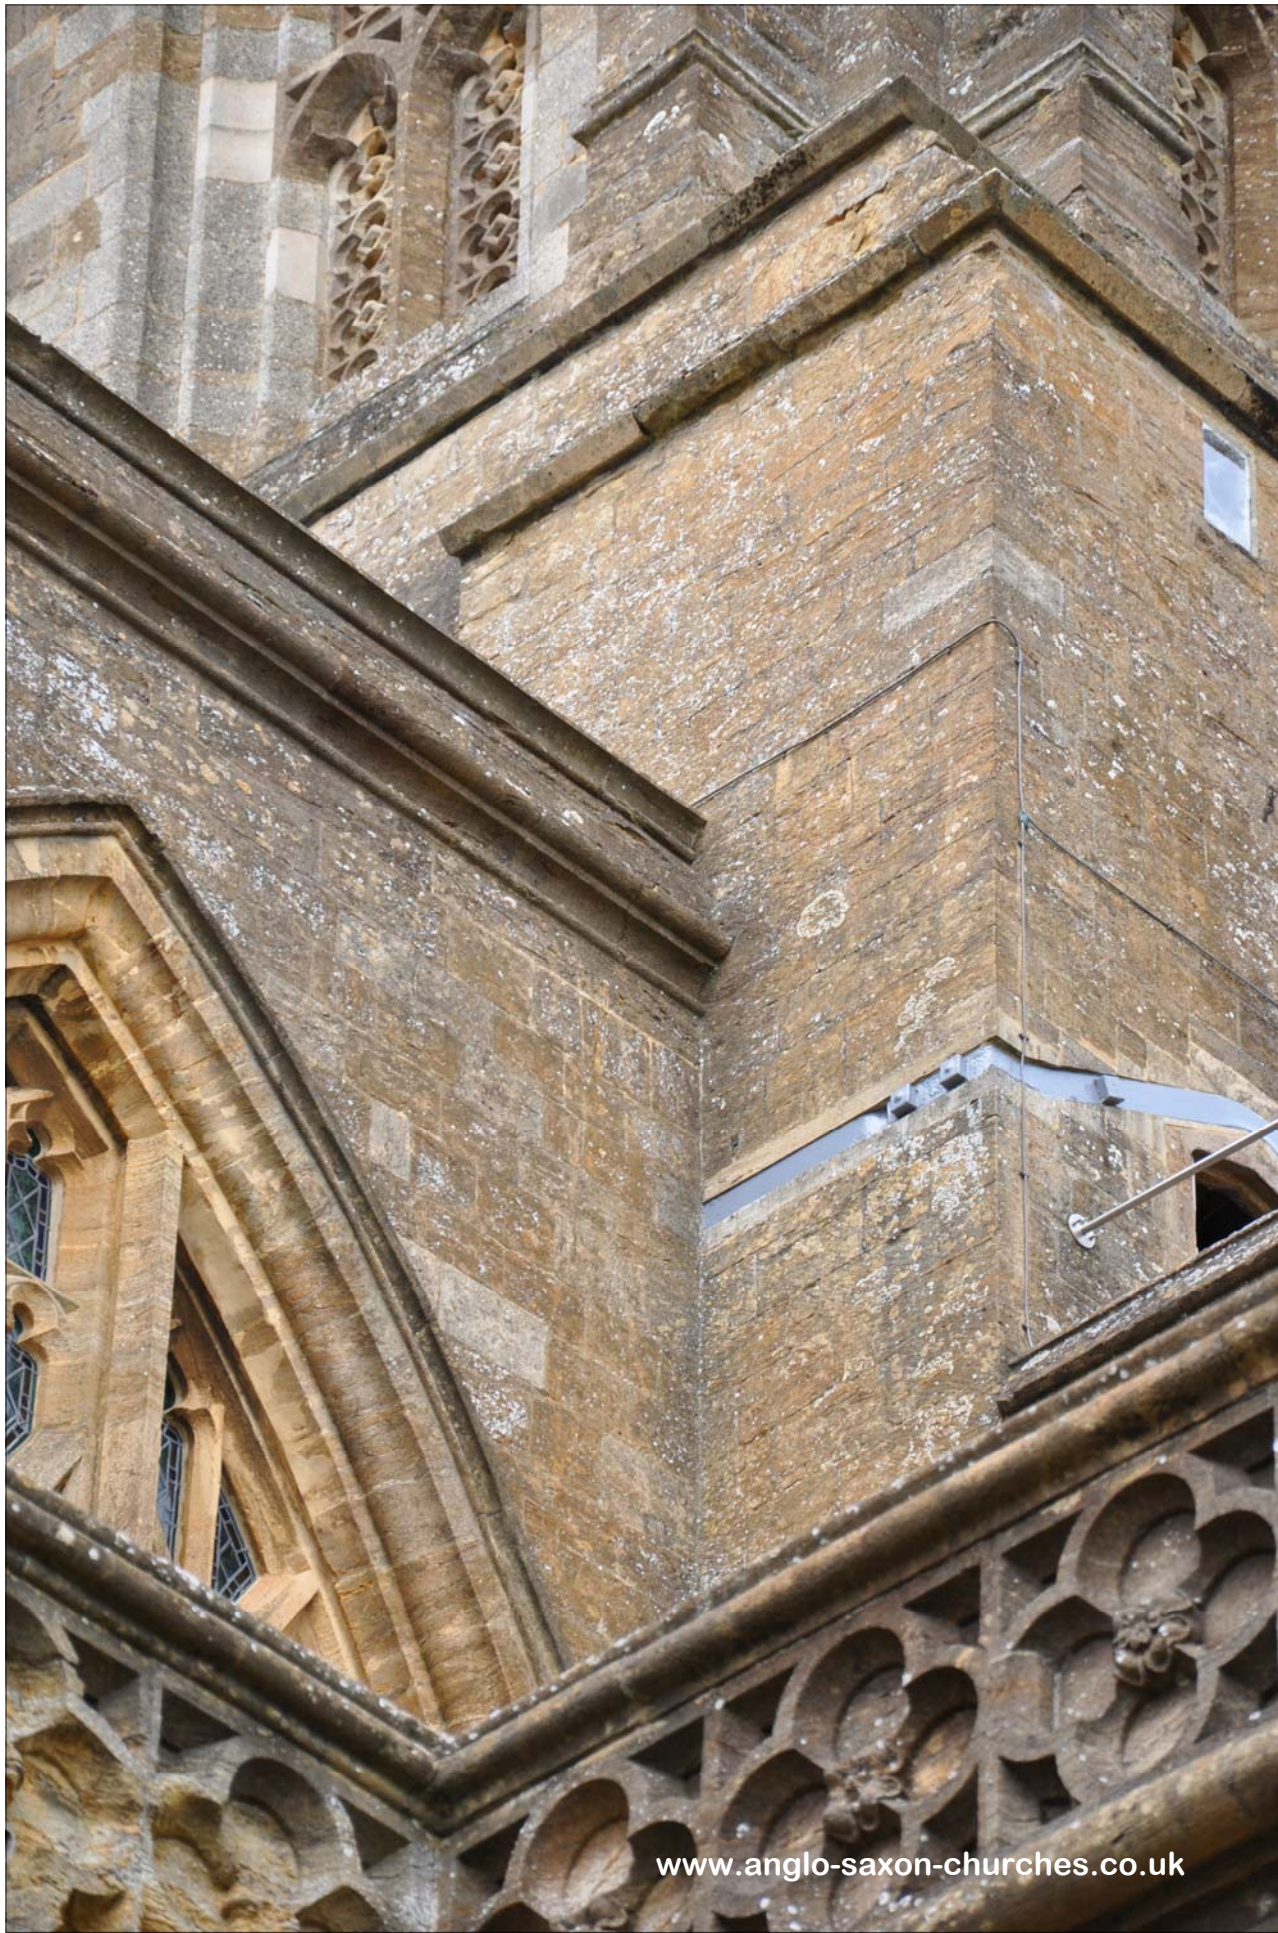
This page; part of the crossing viewed from the SW. Note how the nave (which runs to the left) is decidedly narrower than the crossing, a Saxon feature and not found in post conquest work. Indicates the core of the walling is Saxon, it has simply been extended upwards during later rebuilds.
